## THE GARLAND COMPANY, INC.

**Re: 2015 Roof Evaluation**

TITLE: District Wide Roof Review

COMPANY: Rush City Public Schools

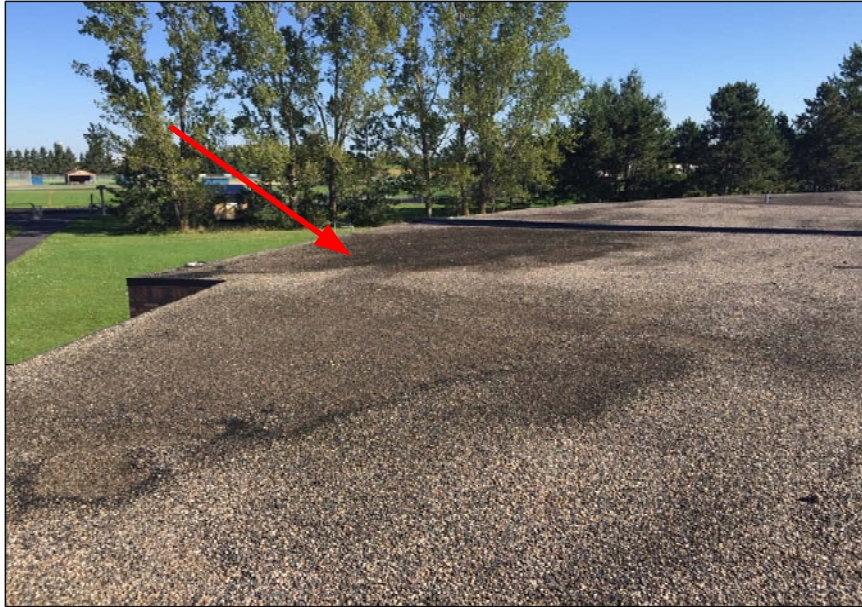
The older built-up roofs have very little slope, which is leading to moderate amounts of ponding for days after periods of rain (SEE PHOTOS). This ponding is certainly a contributing factor to the premature deterioration of the roof system. As the built-up roof systems age they tend to ridge then split in the field of the roof and the perimeter base flashings tend to deteriorate from UV exposure (SEE PHOTOS).

Overview of ponding conditions due to improper slope in the roof surface.

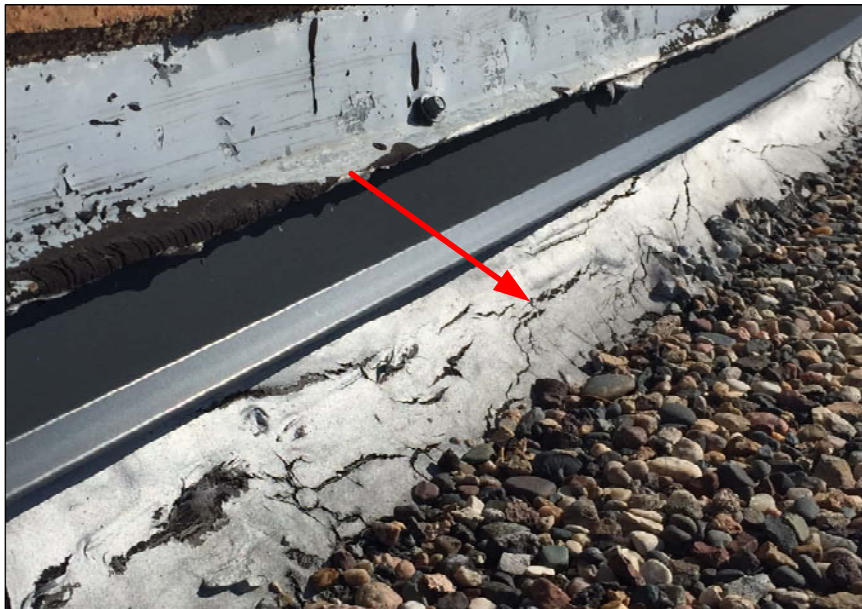
Deteriorated flashings and potential interior leak locations.

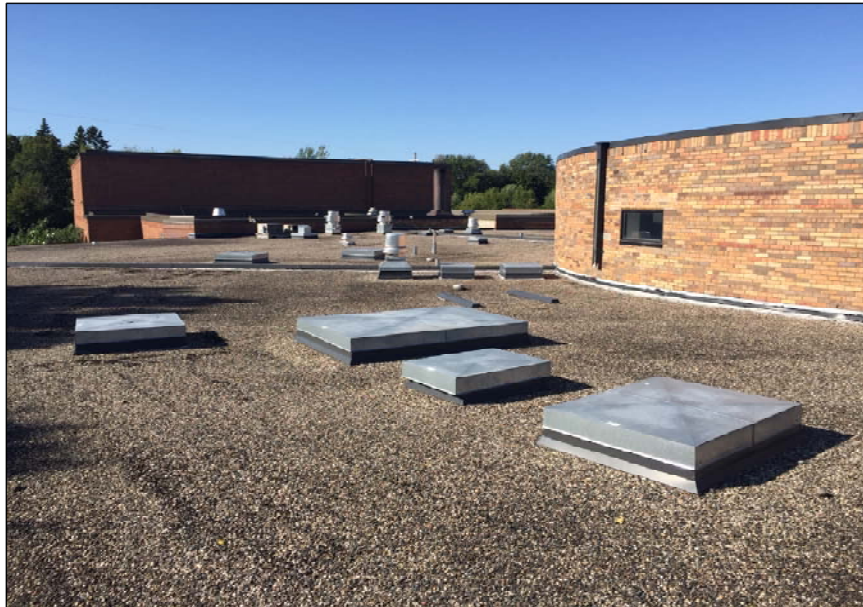
Numerous obsolete curbs need to be removed during the next roof replacement project.

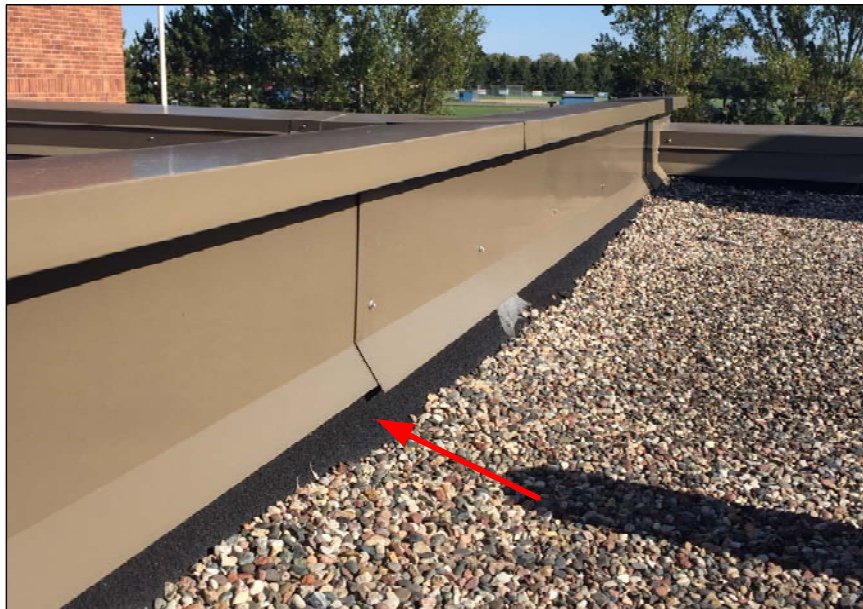
Exposed base flashings that should be coated or covered to avoid further damage.

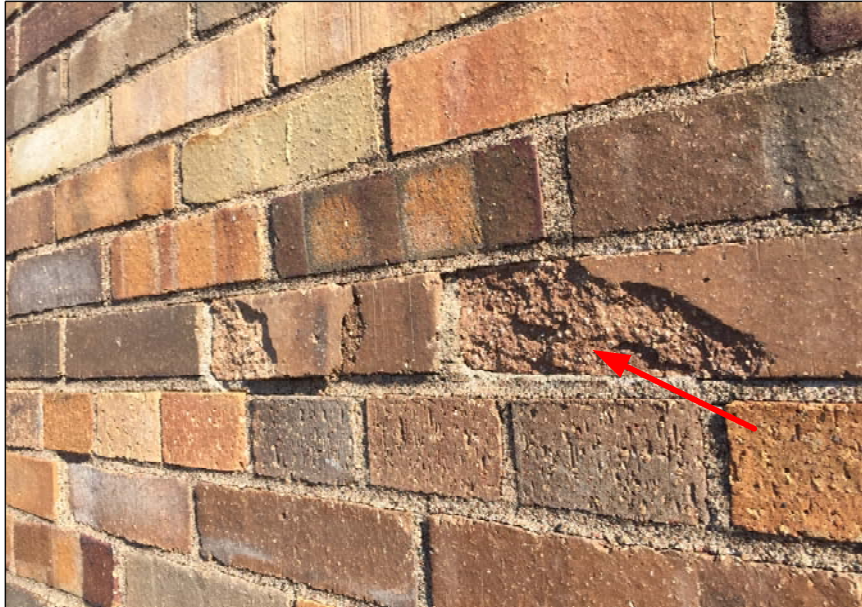
Deteriorated brick/mortar that will need to be addressed during the roof project.

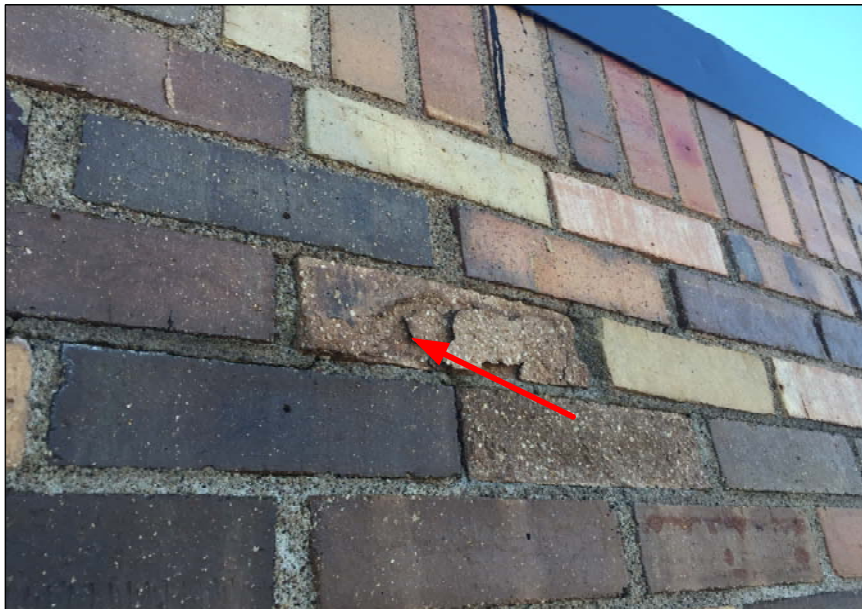
Additional failure.

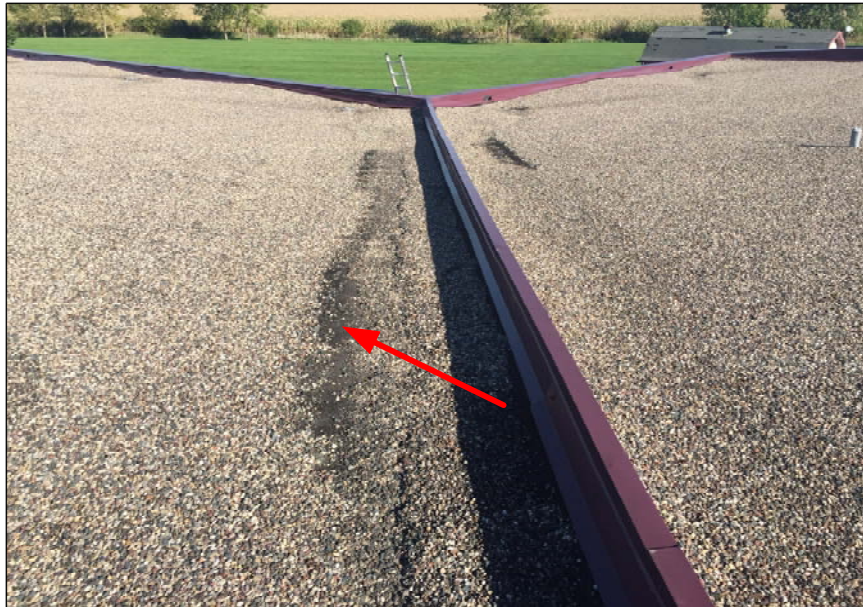
Erosion of the flood and gravel surfacing. Maintenance can be completed to protect these areas of exposed felts.

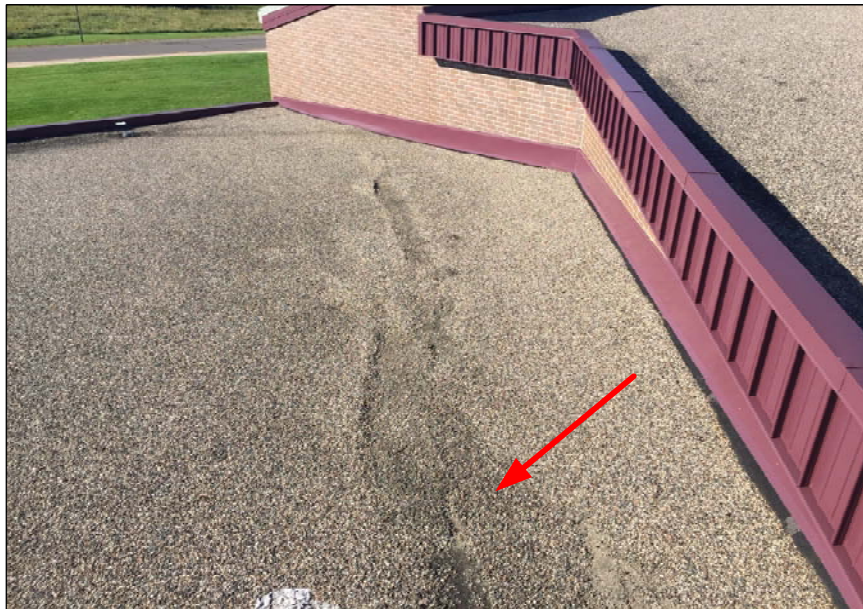
Additional areas of water erosion.

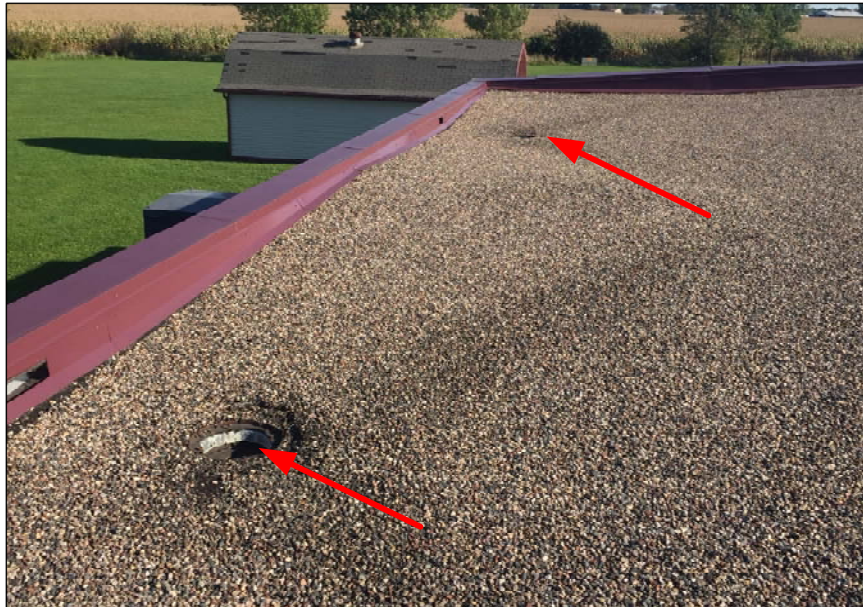
Missing drain strainers need to be replaced.

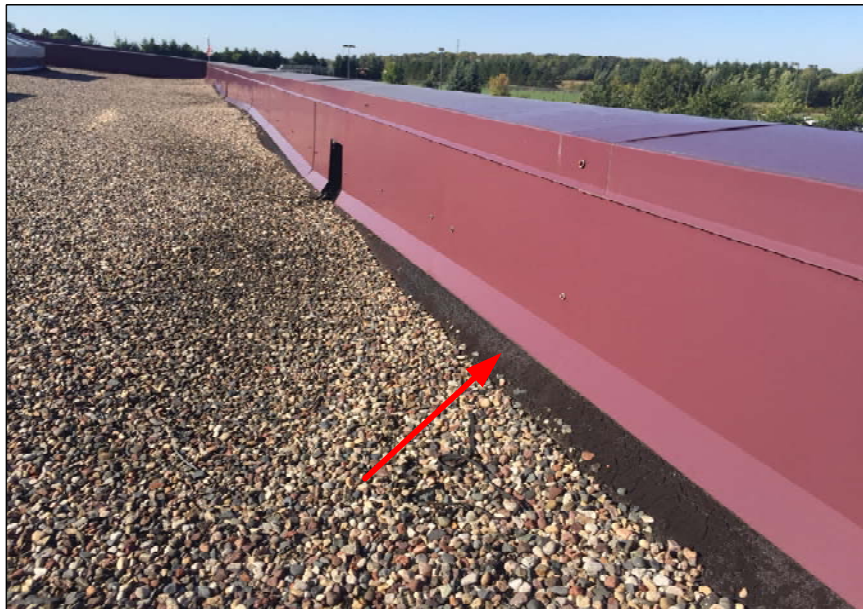
Exposed base flashings need to be coated or covered to minimize future deterioration.

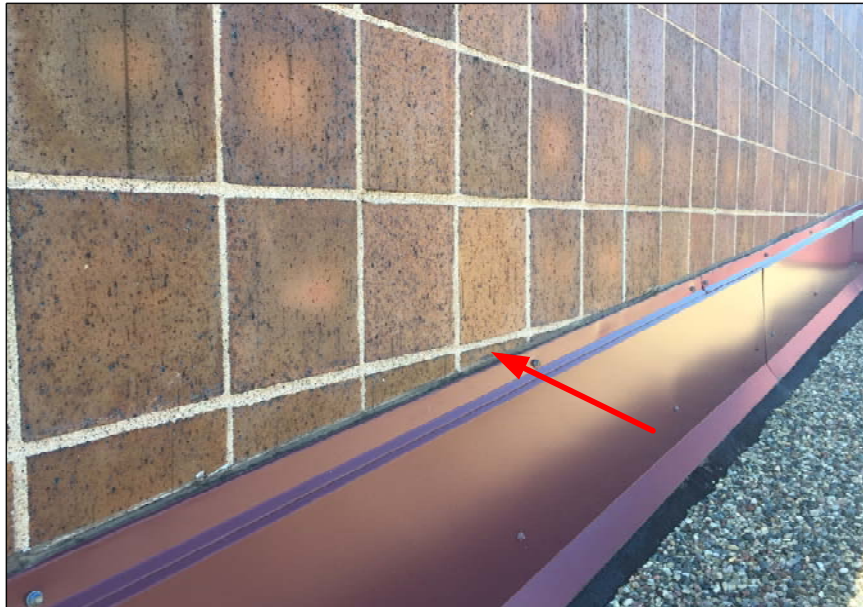
Wall drainage system has been covered leading to leaks.

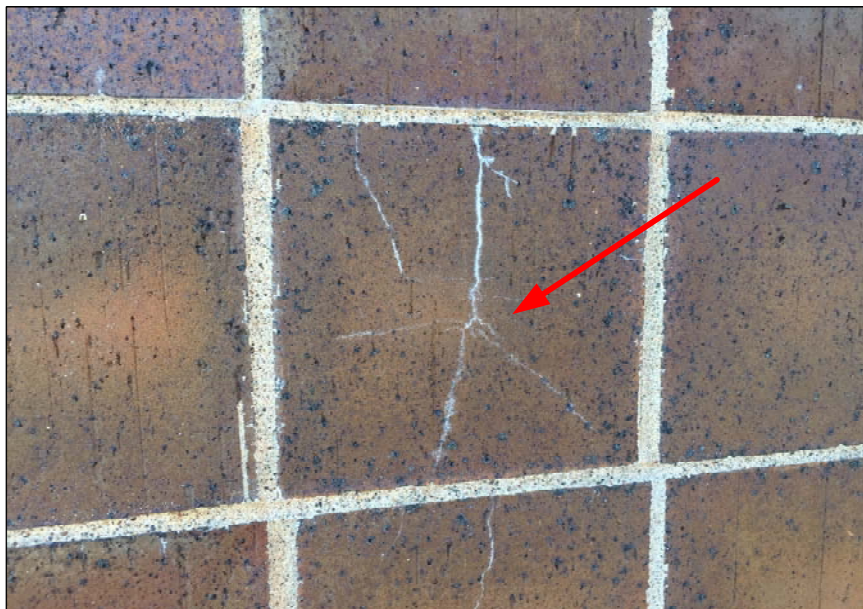
Block deterioration due to infiltration and/or improper drainage.

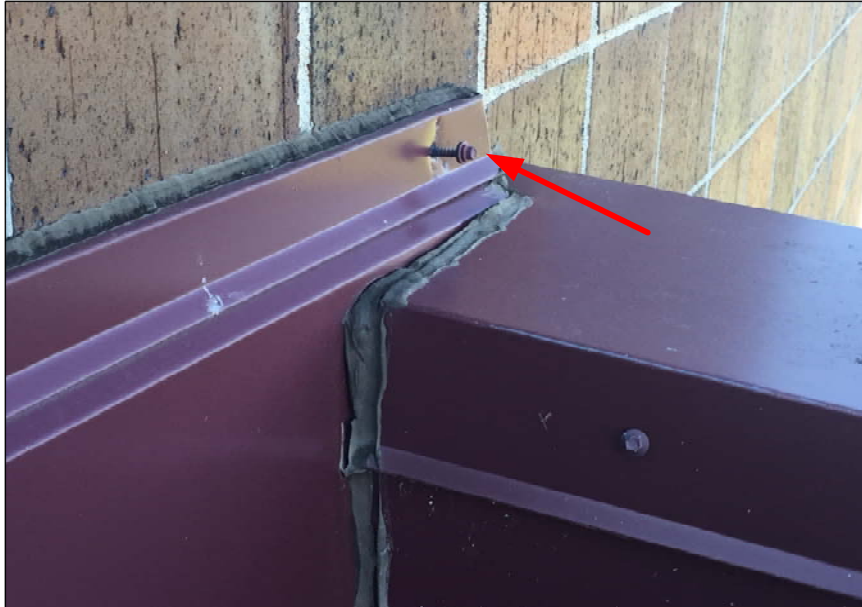
Fastener back out – normal preventative maintenance.

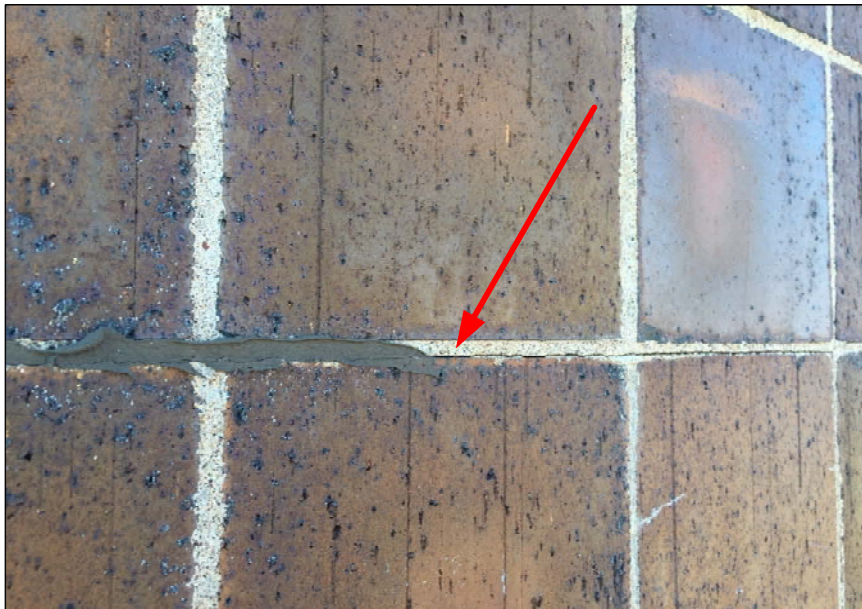
Additional deteriorated mortar leading to leaks.

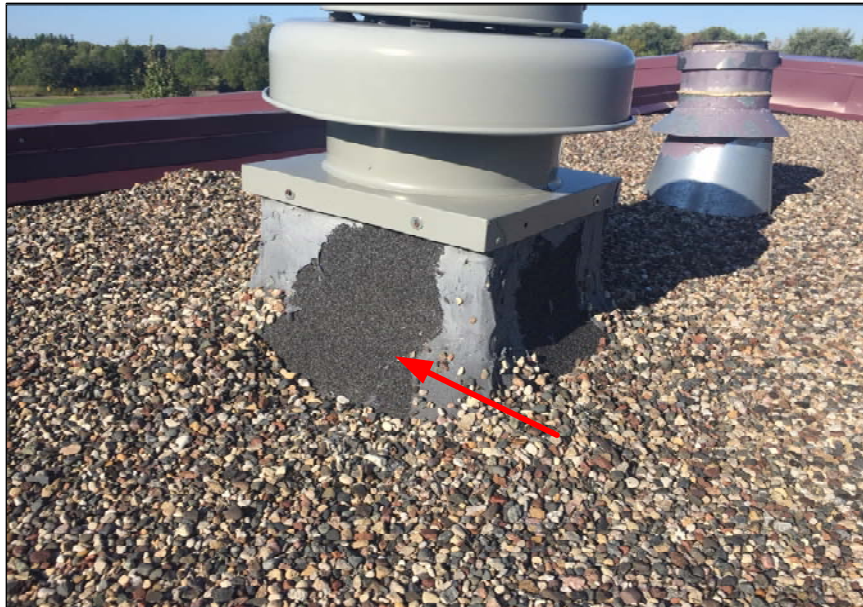
Exposed Flashings

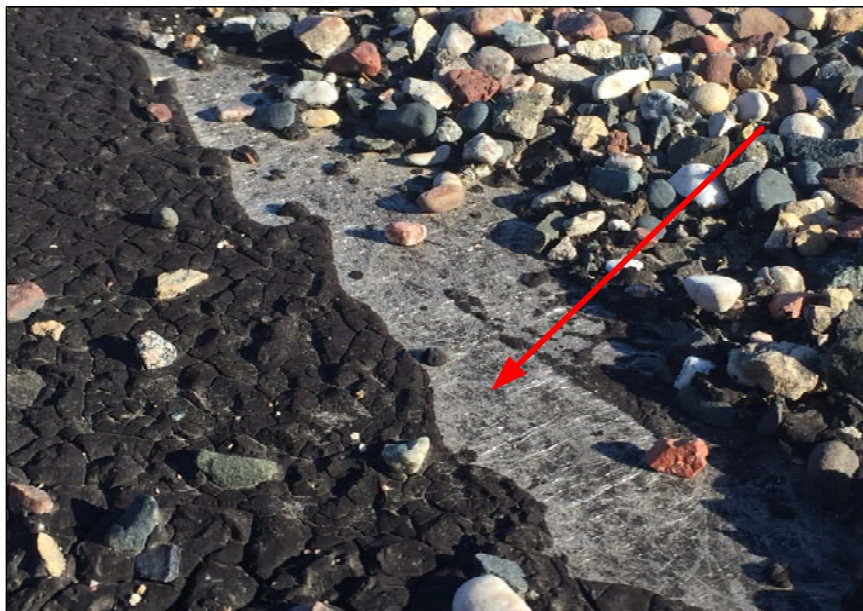
Exposed felts will lead to premature failure of the roof system.
